Manhole Inspection Summary

Manhole # S43EE_036MH

Inspection ☐ Is Incomplete Rating: **4) Poor**

Location Address: **1634 CHASE ST**

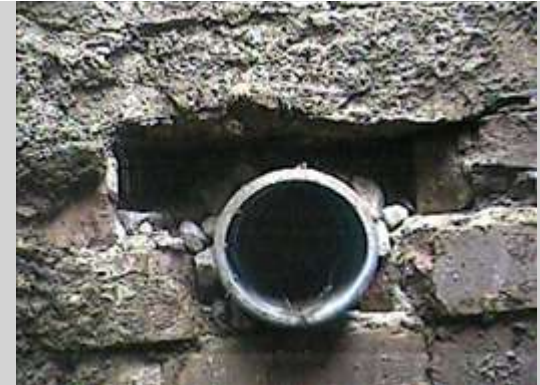
12 O'Clock Inflow

4 in. Circular Gravity Sewer
Pipe In @ 12 O'Clock

Pipe Material: **PVC** ☐ Pipe Lined

Infiltration: **None**
